SANTA YNEZ RIVER FLOOD CONTROL MIGUELITO ROCK-ASPHALT CHANNEL LINING

F. Earle Ross
Flood Control Engineer

UNITED STATES DEPARTMENT OF AGRICULTURE
Soil Conservation Service **Pacific Region**

Miguelito Rock Channel Lining

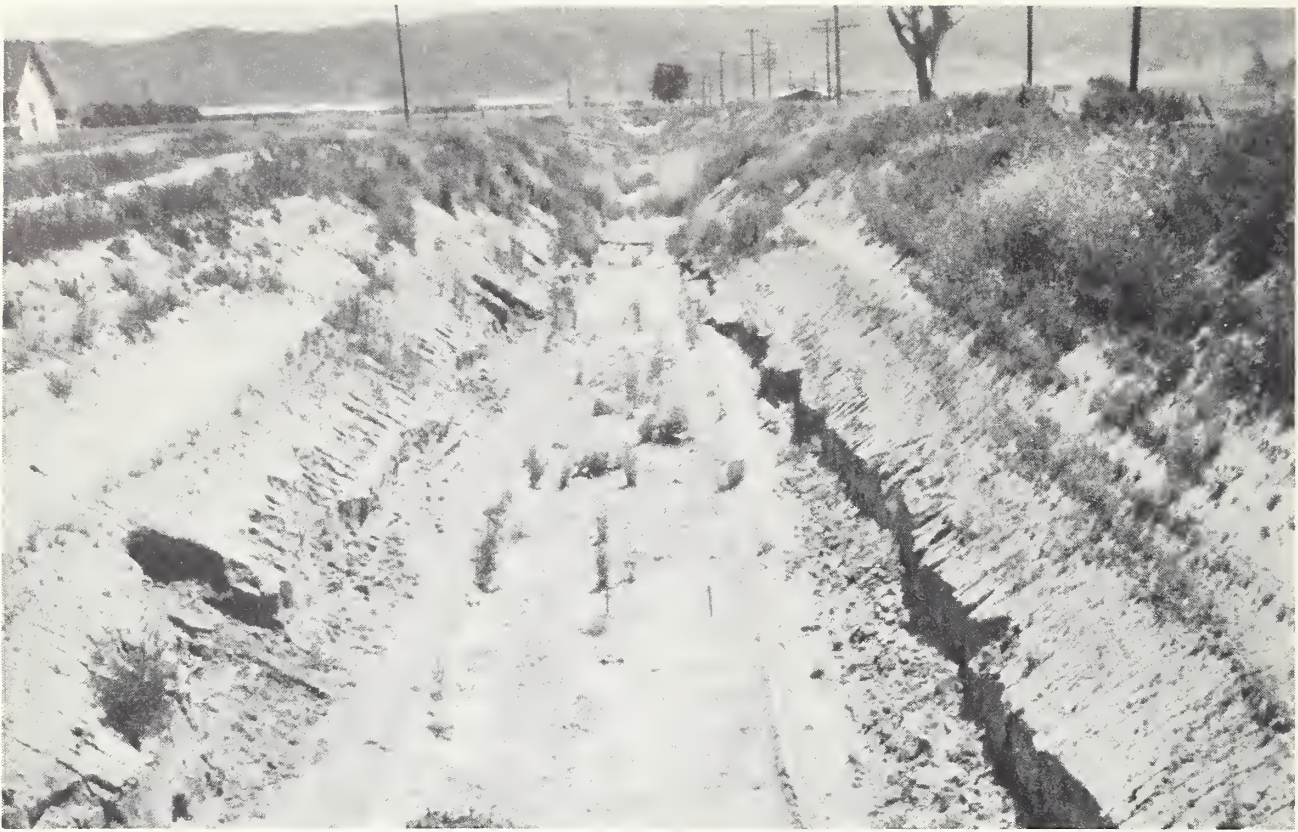
Two conditions of soil instability were encountered: (1) Station 43+00 to Station 48+15 a light textured soil in the lower strata was subject to erosion from channel flow, (See Photo 1). This channel reach was treated by placing a layer of graded river run material in a parabolic section over the original trapezoidal earth channel, 6 inch minimum thickness at the center and edges of the section and a minimum thickness of 18 inches at the toes of the slopes. River run material was selected to resist drag force without binder and conformed to the gradation: (See Photo 2)

Photo 1. *Miguelito Flood Channel, looking upstream from private vehicular bridge 1 mile south of Central Avenue, showing erosion damage to toe of earth section. This damage developed in a thick layer of non-cohesive material near channel grade.*

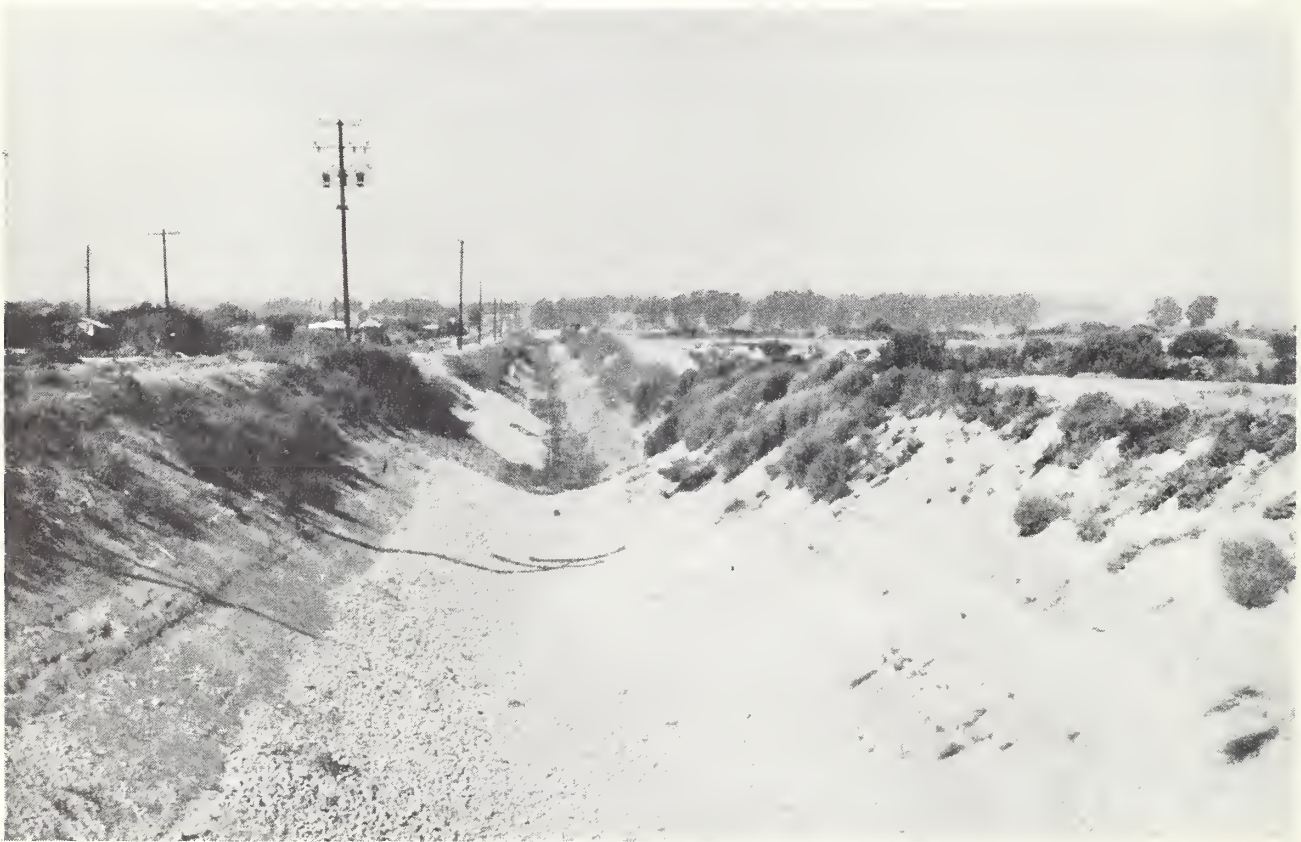
Photo 2. *Miguelito Flood Channel, looking downstream from private vehicular bridge 1 mile south of Central Avenue, showing catenary shape of coarse loose rock fill in bottom of the channel.*

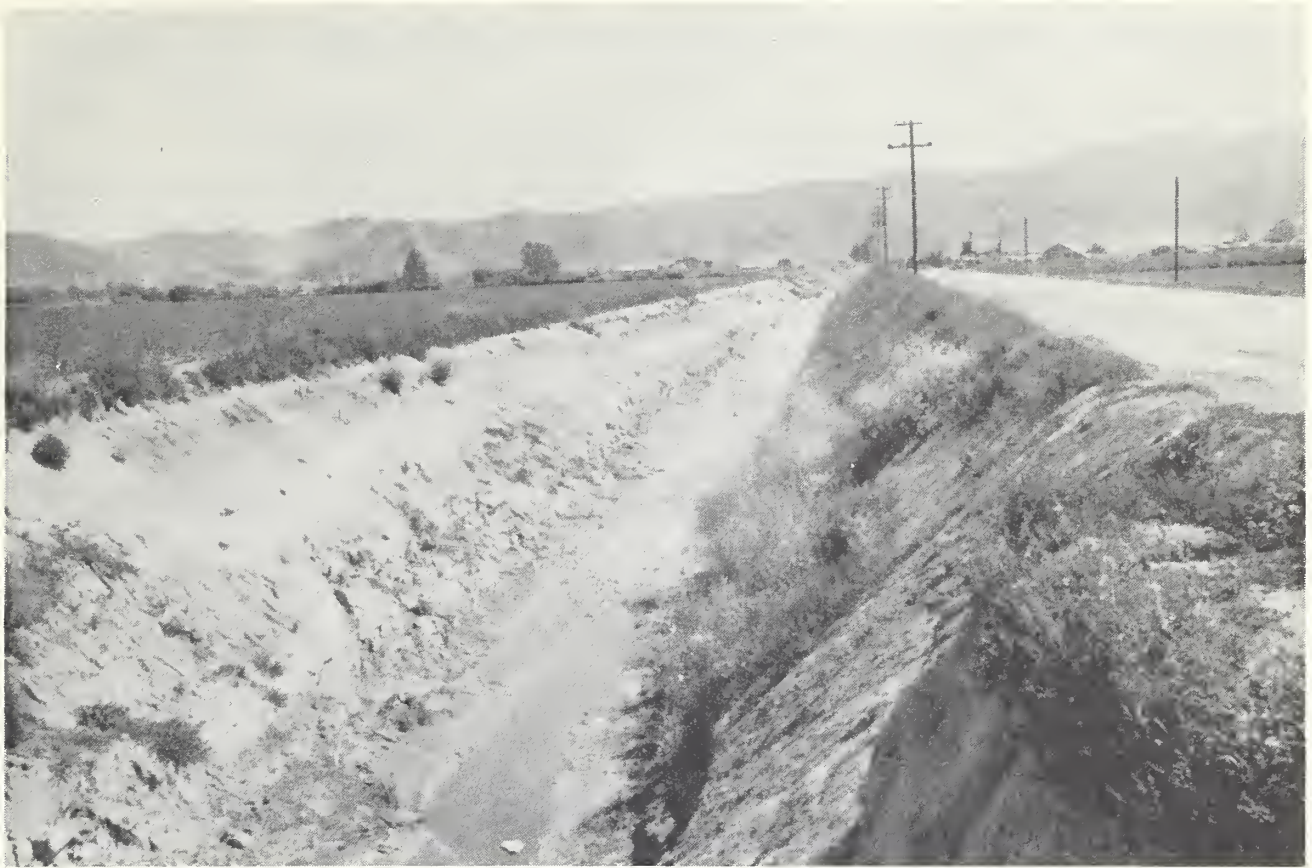
(2) Station 10+00 to Station 43+00 unstable heavy (fine) textured soil was encountered in the lower strata of the channel, (See Photos 3 and 4). This soil when subject to wetting and drying had a tendency to crack, and being underlain with supersaturated material sloughed out. Due to ground water a permeable type lining was required. This section was treated in a manner similar to reach (1) except that no attempt was made to obtain rock graded to resist displacement. Crushed rock was used in the following gradation and the surface treated with an emulsified asphalt binder at the rate of 4.43 gallons per square yard applied in one application.

Photo 3. *Miguelito Flood Channel, looking upstream from Central Avenue, showing sloughing along toes of channel excavation. Sloughing occurred in a layer of unstable silt clay material.*

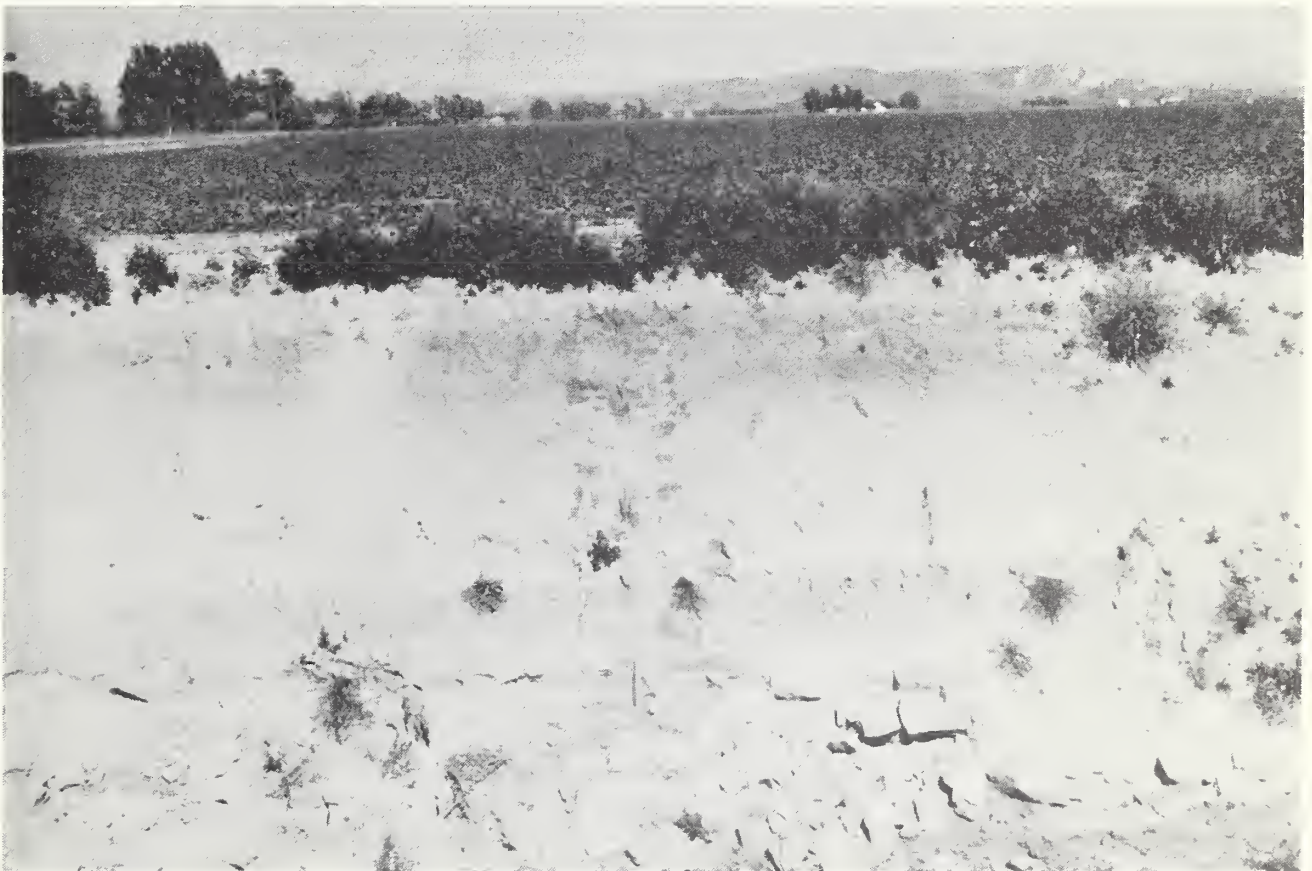
Photo 4. *Miguelito Flood Channel, view taken immediately above Central Avenue, showing nature of fracture in silt clay layer. See Photo 3 above.*

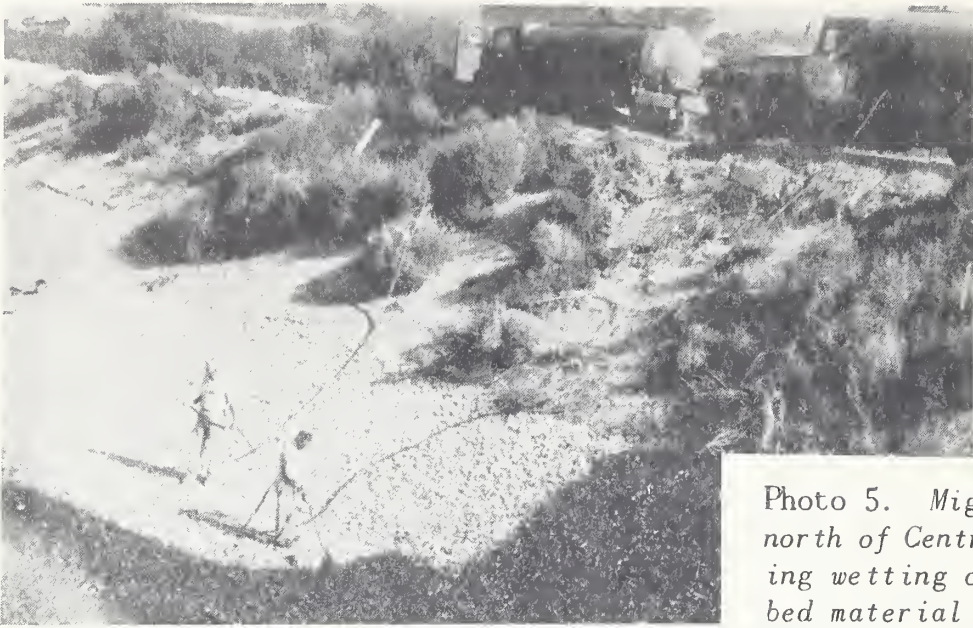
Photo 5. Miguelito Flood Channel north of Central Avenue, view showing wetting of coarse rock gravel bed material and hand-spraying of emulsified asphalt binding material.

Emulsified asphalt was applied by pressure type distributor trucks, equipped with emulsified asphalt type spray jets. Hand applicators were used, (*See Photo 5*), to establish the rate of application. This was done in the presence of Mr. C. W. Thomas, Soil Conservation Service, and Mr. Lackey of the American Asphalt Institute. The depth of penetration sought was 4 inches, which was estimated to require 1 gallon per square yard per inch of depth. Rate of application for depth of penetration required can best be obtained by field trial. Specifications for application of the oil should reserve the right to adjust the rate of application and the total amount applied. The hand applicator method required several passes which allowed puddling and a build up of oil on the surface rock. To gain greater penetration and eliminate surface puddling a spreader bar was constructed and attached to the blade of a D-4 bulldozer, (*See Photo 6*), permitting all of the oil to be applied in one application. The surface of the rock was wetted immediately prior to placing the oil binder, in all methods of application. Attachment of the spreader bar to the blade of the D-4 bulldozer required that the operation be halted every 8 to 10 feet as the distributor trucks were unable to supply sufficient oil under pressure and power to the drivers simultaneously. This resulted in an overlap of oil each time the tractor was halted. To overcome this situation the spreader bar was attached to the leads of a truck crane with boom extended and the distributor truck towed by the truck crane enabling a constant flow of oil at a constant speed, (*See Photo 7*).

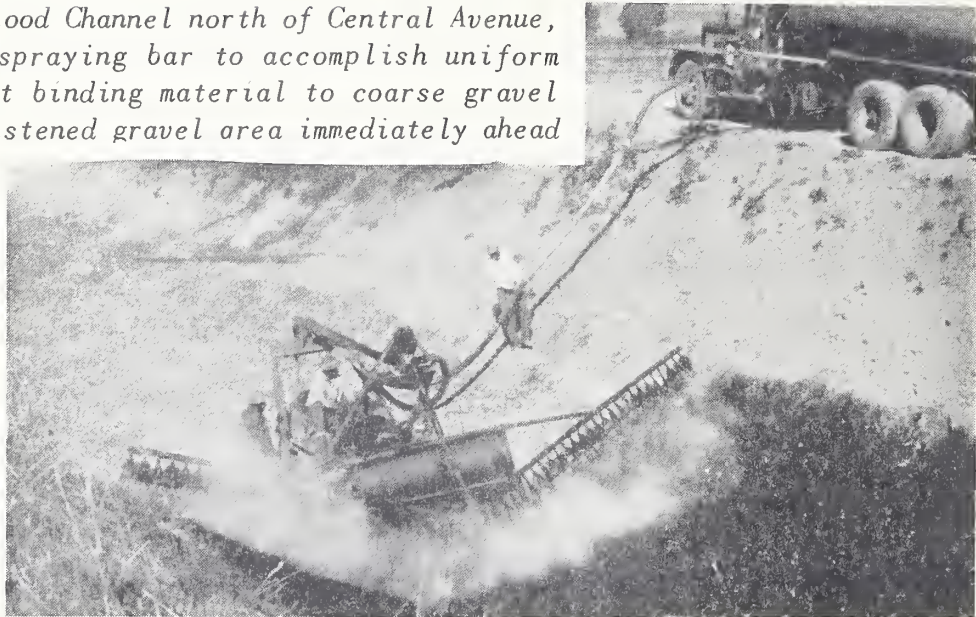
Photo 6. Miguelito Flood Channel north of Central Avenue, view showing use of spraying bar to accomplish uniform application of asphalt binding material to coarse gravel bottom fill. Note moistened gravel area immediately ahead of asphalt machine.

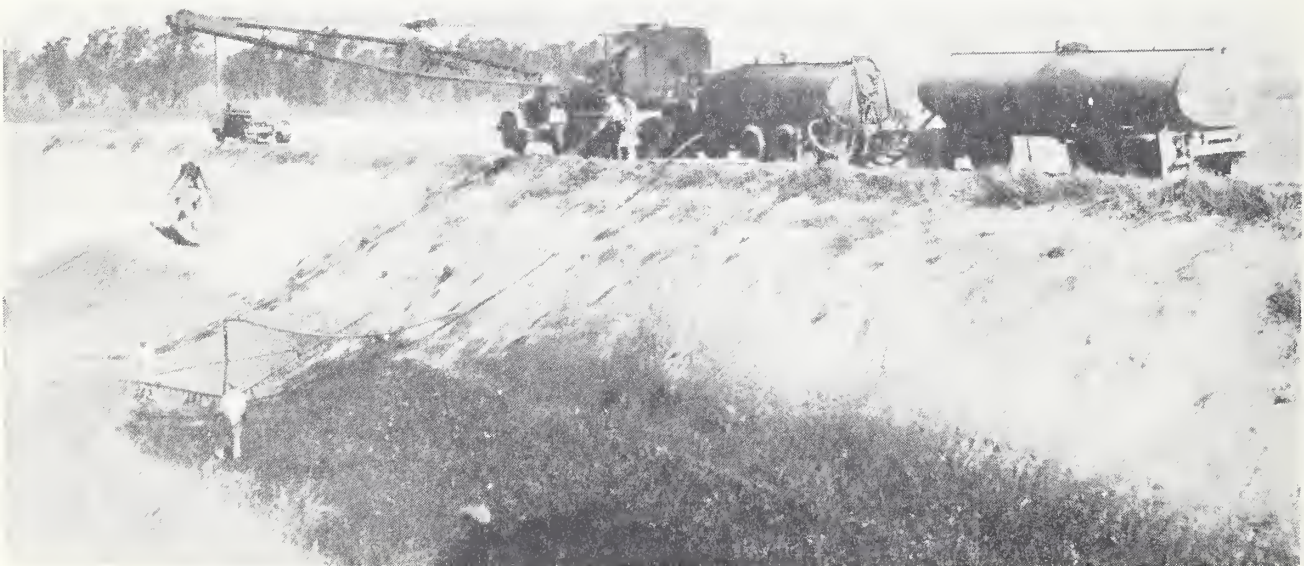
Photo 7. Miguelito Flood Channel, view showing use of clam bucket to move asphalt spray bar.

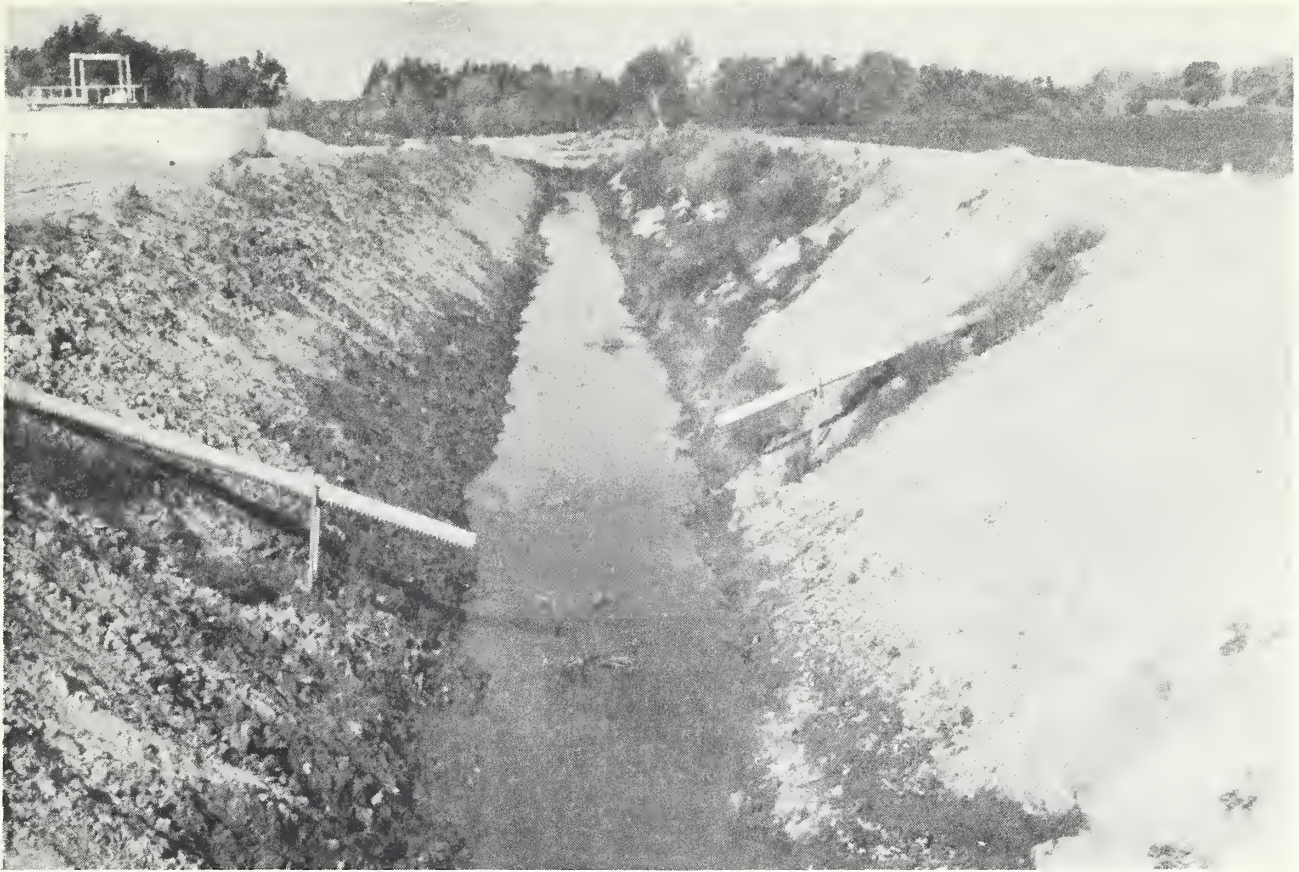
Photo 8. *Miguelito Flood Channel, view looking downstream from Central Avenue, showing unstable nature of channel bottom material.*

Ground water Station 10+00 to Station 16+37- was pumped down during placement of rock and emulsified asphalt application and maintained dry for a period of 24 hours to enable the asphalt binder to set up. (*See Photos 8 and 9*).

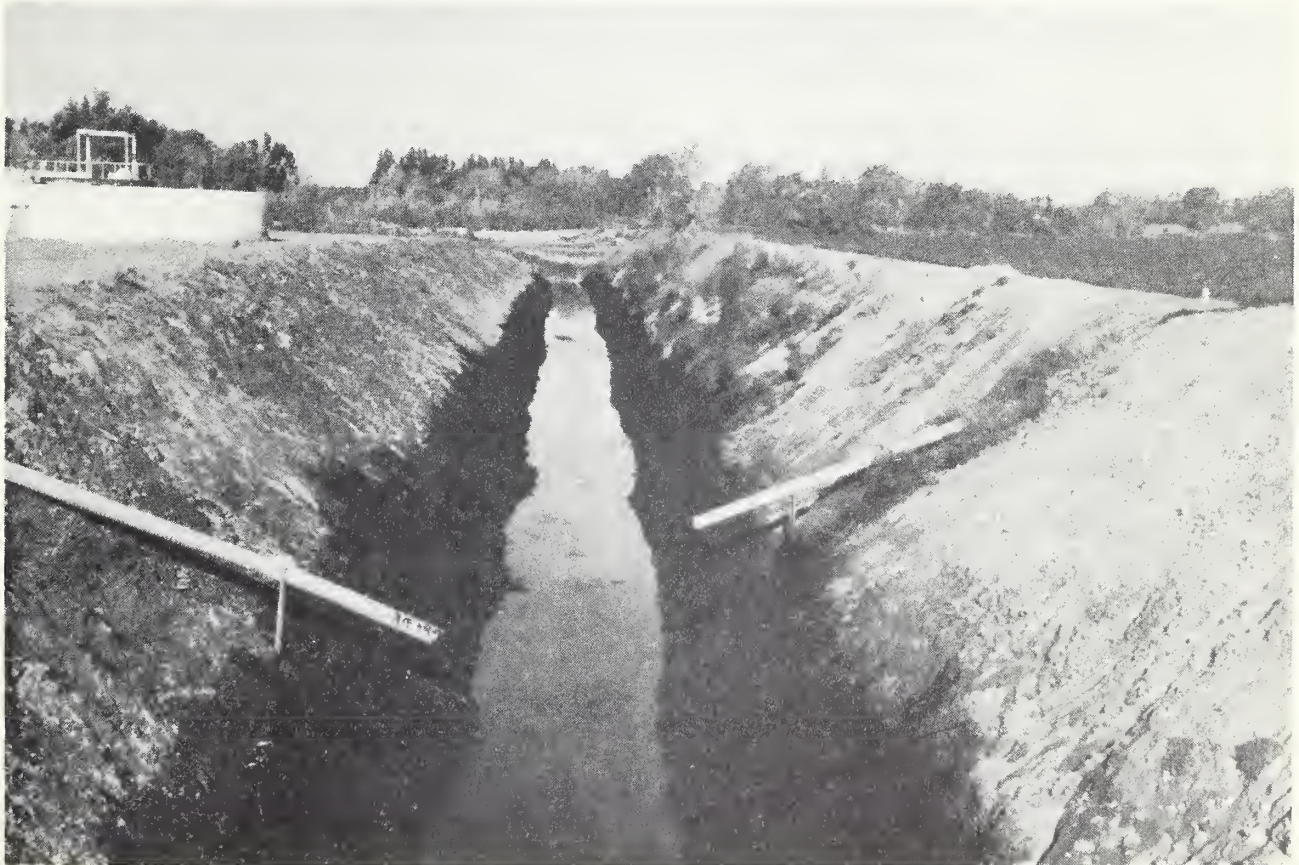
Photo 9. *Miguelito Flood Channel, looking downstream from Central Avenue, showing condition of channel immediately after application of coarse gravel and application of emulsified asphalt binding material.*
